### Repair of parking areas and taxiways at Barcelona/ESP airport

#### Replacement of floor plates using Concretum® Q-FLASH 2/20

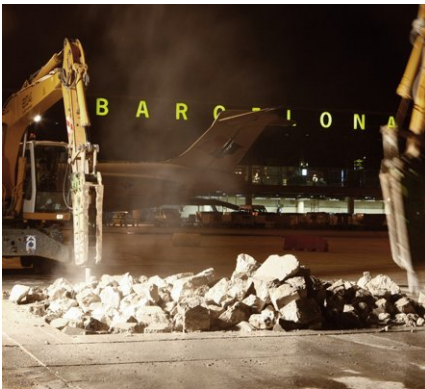
Dismantling of the old slab

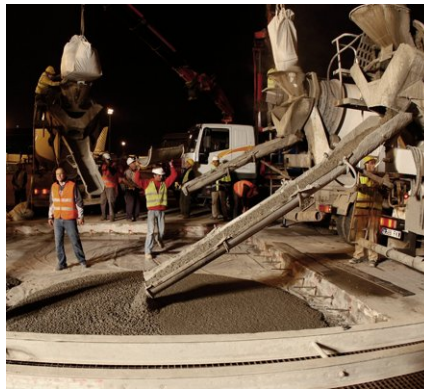
Casting of the new slab

The rapid hardening concrete Concretum® Q-FLASH 2/20 reaches a compressive strength of 20 N/mm<sup>2</sup> two hours after adding the water while the workability is 50 to 70 minutes. In addition, Concretum® Q-FLASH 2/20 is a shrinkage reduced concrete, which results in a crack-free and durable surface. For the operator (AENA Barcelona) this means that the replacement of the floor plates can be done gradually and with no adverse effect regarding the air traffic even with the above-described difficult initial status. As there is no concrete plant close to the airport the concrete is produced directly in a ready-mix concrete truck. First the trucks are loaded with aggregates and main water. With this load the trucks roll together to the construction site where they are placed around the empty plate. The addition of binder is now made directly from big bags into the ready-mix concrete truck. To adjust the requested consistency of concrete extra water is added finally. All trucks unload together into the designated place for the slab. The visco-plastic consistency of the concrete requires only a compaction

on a low level and the surface can be leveled by vibrating beams. Usually the slab that has to be replaced is closed off at 8 pm and can be released again for air traffic at 6 am.
