### Repair Reppischbrücke, Birmensdorf (ZH)

Repair of bridge plate and replacement of shoulder curb

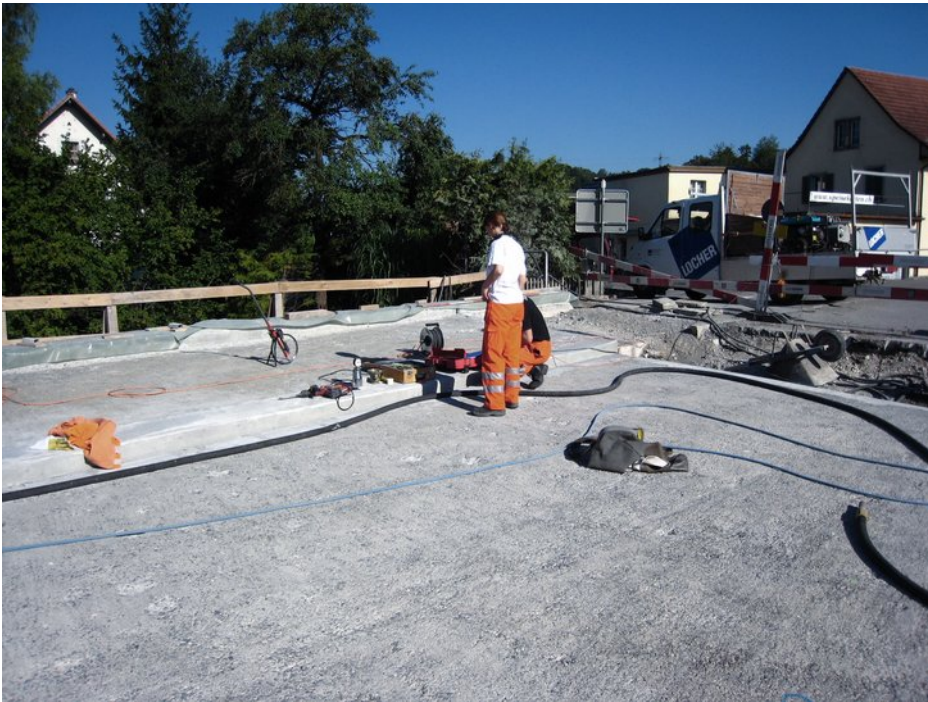
The busy Reppischbrücke at the beginning of Birmensdorf/ZH was completely repaired in 2007. The strongly chloride-contaminated shoulder curbs were replaced. The old carriageway surfacing was removed and the battle deck bridge floor repaired.

To reliably avoid shrinkage cracking in the freshly constructed shoulder curbs and to guarantee a long repair-free occupancy period of the bridge for the future, the low-shrinking type of concrete Concretum® D-ZERO Plus was used. To keep the construction time and the disturbance of the traffic as low as possible, the rapid-drying type of concrete Concretum® Q-FLASH 10h was used for the repair of the battle deck bridge floor. The choice of this material allowed the sealing and shortly afterwards the surfacing only 48 hours after the concreting work. Concretum® D-ZERO and Concretum® Q-FLASH 10h meet all requirements to a high-quality FT-concrete (C30/37, XC4, XD3, XF4) and can be listed pursuant to norm SN EN 206-1.
